# MARKET STREET BICYCLE/PEDESTRIAN ACCOMMODATION STUDY

Harrisburg Area Transportation Study

## 2 ROADSIDE SAFETY AUDIT

### 2.1 Existing Conditions and Deficiencies

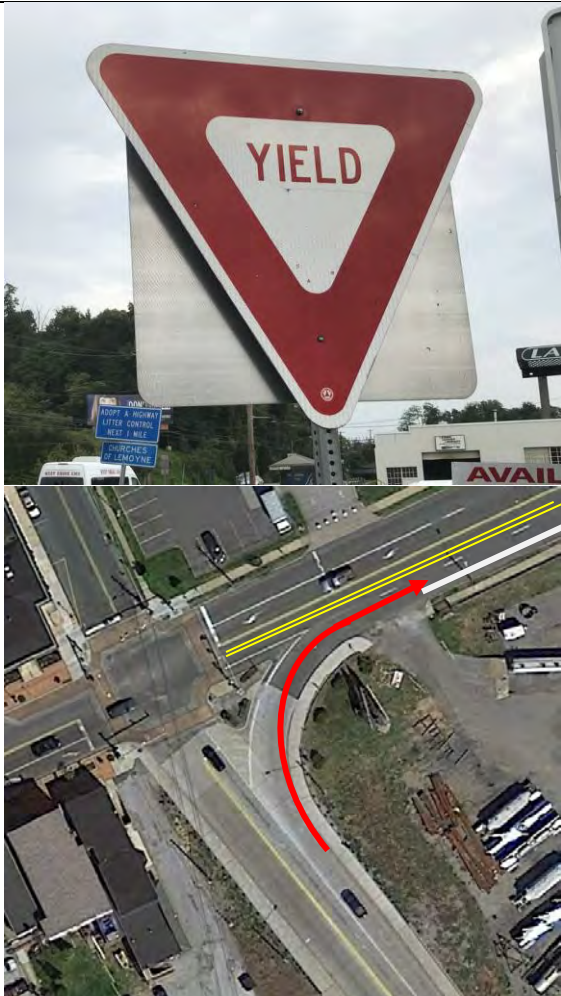
<p><b>Deficiencies:</b> Under current conditions the YIELD sign on the northbound approach is not needed for the channelized right turn lane. Since there is an added lane, motorists turning right have no need to yield to drivers traveling along Market Street (refer to the bottom left photo).</p> <p><b>Corrective Actions:</b> Reducing the two travel lanes in the eastern direction to one lane to accommodate a bike lane will require the YIELD sign be maintained. However, the DO NOT ENTER sign mounted on the reverse side of the YIELD sign should be mounted on a separate post and located so as not to visually impair the YIELD sign.</p>

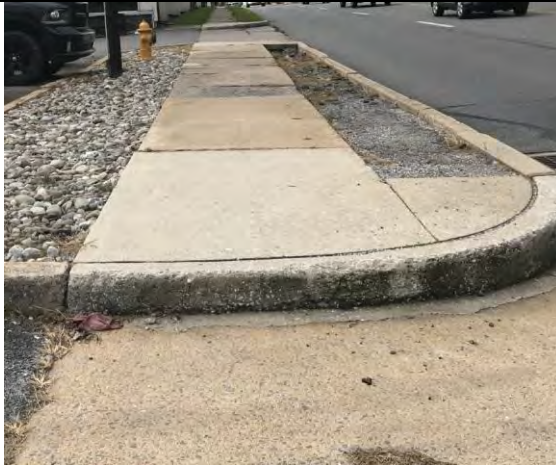
<p><b>Deficiencies:</b> Sidewalk at the driveways along the south side of the east leg do not meet ADA requirements (lack of curb cuts). The pavement at the driveway is in poor condition and can present a tripping hazard for pedestrians.</p> <p><b>Corrective Actions:</b> <b>Install ADA required curb cuts.</b></p>

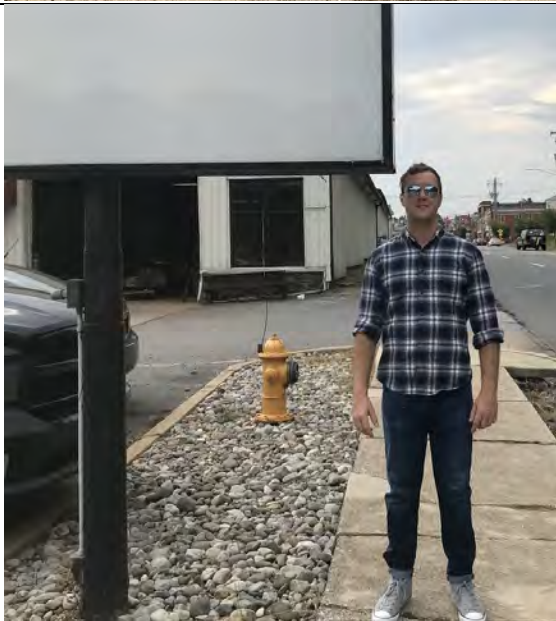
<p><b>Deficiencies:</b> The large sign on the sidewalk along the south side of the east leg is mounted too low for a pedestrian area. All signs should have a mounting height of at least 7 feet from the ground to the bottom of the sign.</p> <p><b>Corrective Actions:</b> Adjust the mounting height of the sign.</p>

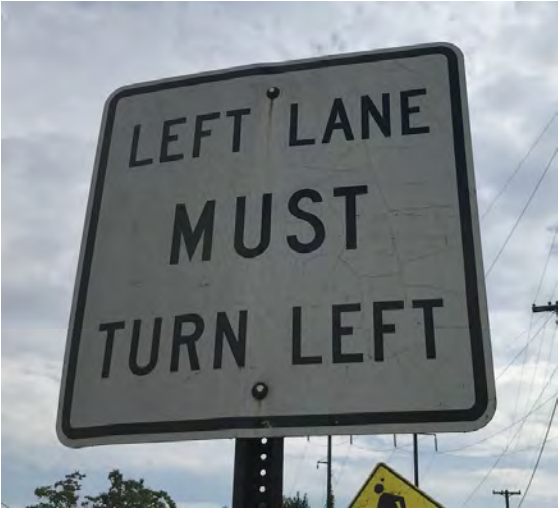
<p><b>Deficiencies:</b> Many of the signs use Type I sheeting. All regulatory, warning, and guide signs with a green background should utilize Type III or higher sheeting as stated in section 2A.08 of the DoD Supplement to the MUTCD. This sheeting provides levels of retroreflectivity to ensure the signs can be seen during nighttime or low-light conditions.</p> <p>Refer to Section 2A.08 of the CA MUTCD for standards and guidance relating to maintaining minimum retroreflectivity. The Federal Highway Administration (FHWA) also provides a retroreflective sheeting guide to help identify sheeting types: <a href="https://safety.fhwa.dot.gov/roadway_dept/night_visib/sign_visib/sheetguide/">https://safety.fhwa.dot.gov/roadway_dept/night_visib/sign_visib/sheetguide/</a></p> <p><b>Corrective Actions:</b> Replace all signs with Type III sheeting or better.</p>

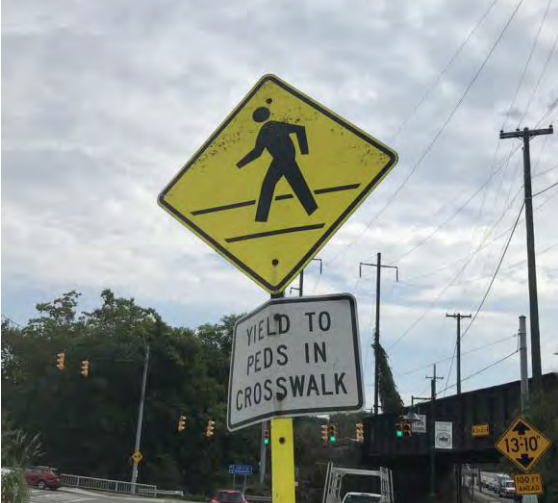
<p><b>Deficiencies:</b> The pedestrian signage on the southbound approach is not compliant and not necessary for a controlled approach.</p> <p><b>Corrective Actions:</b> Remove the pedestrian signs.</p>

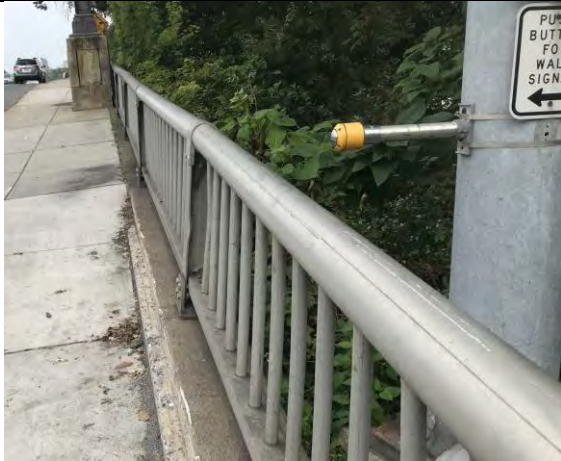
<p><b>Deficiencies:</b> According to section 4E.08 of the MUTCD, pedestrian push buttons should be placed within easy reach of pedestrians. The push button at the westbound approach is not easily accessible for pedestrians in a wheelchair or with other disabilities.</p> <p><b>Corrective Actions:</b> Install a longer extension arm to ensure the pedestrian push button is easily accessible.</p>

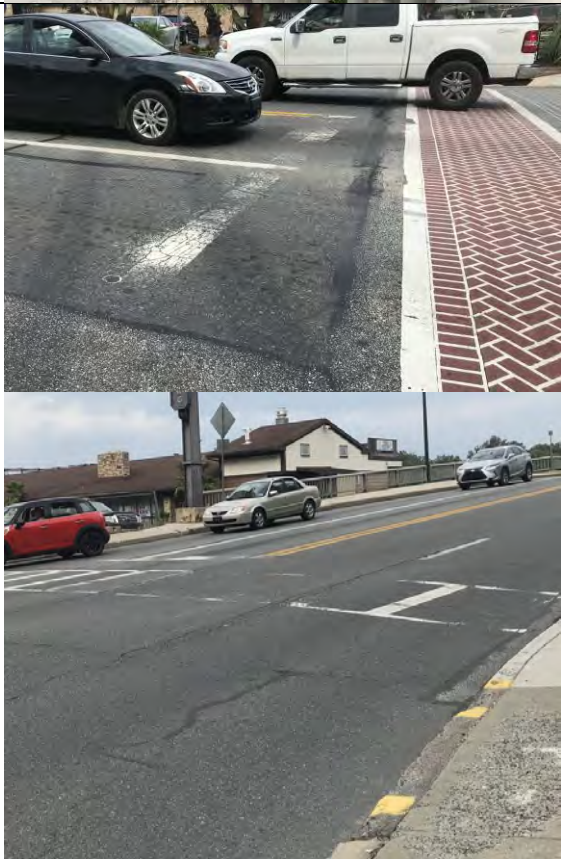
<p><b>Deficiencies:</b> The stop lines and crosswalk markings at the intersection are faded and worn.</p> <p><b>Corrective Actions:</b> Restripe the faded stop lines and crosswalk markings.</p>

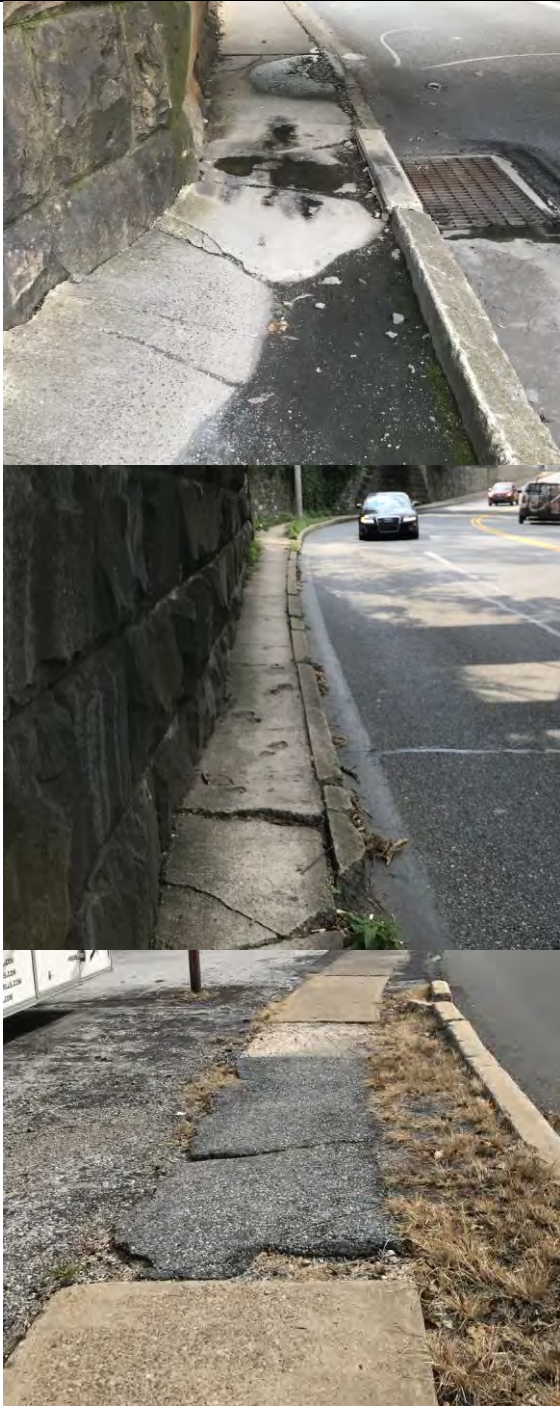
<p>The 'Photo' column contains three images illustrating sidewalk issues. The top image shows a narrow sidewalk with a storm drain and a concrete curb. The middle image shows a narrow sidewalk next to a stone wall. The bottom image shows a sidewalk with asphalt patches and a concrete curb.</p>	<p><b>Deficiencies:</b> Numerous sections of sidewalk along Market Street are too narrow and do not meet ADA requirements. In areas where the sidewalk is a compliant width, the concrete slabs are uneven with some sections replaced with asphalt.</p> <p><b>Corrective Actions:</b> Given that a portion of Market Street is constrained by the railroad bridges, a lane reduction is required to obtain adequate sidewalk width. Refer to the improvements in Section 4 that show an ADA compliant sidewalk network along Market Street.</p>

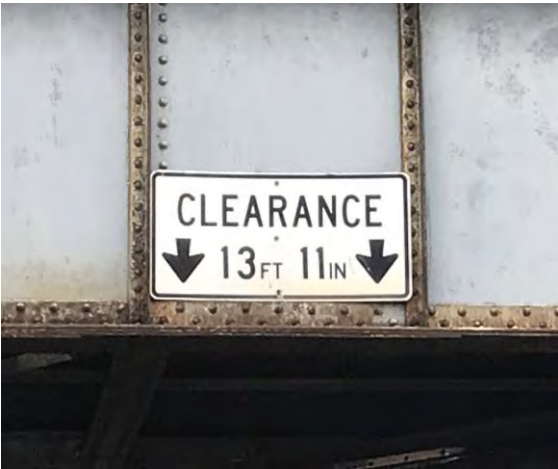
<p><b>Deficiencies:</b> The overhead clearance sign is not compliant.</p> <p><b>Corrective Actions:</b> Replace the sign with the standard W12-2A sign shown below. Ensure that the sign is 78" in width and 24" in height.</p>

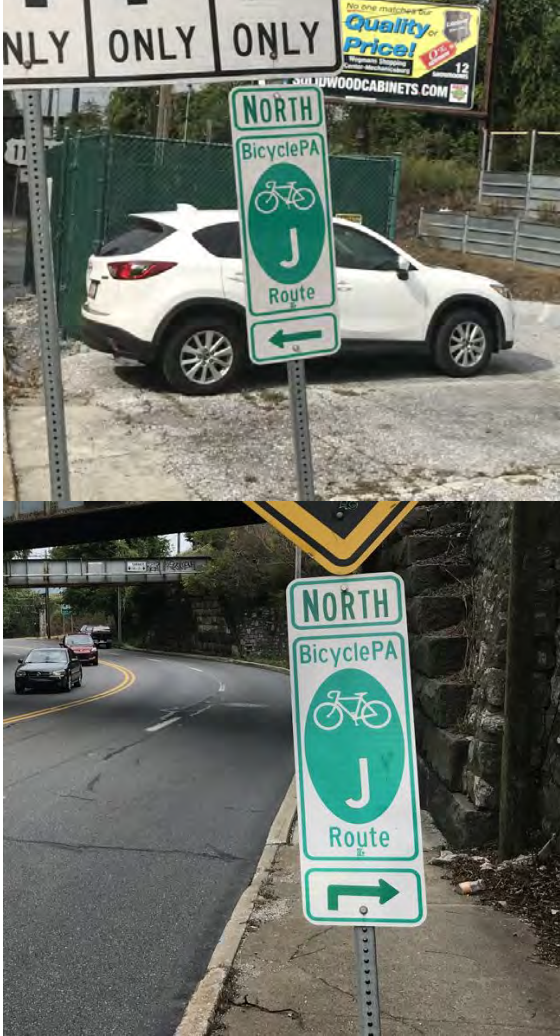
<p><b>Deficiencies:</b> The bicycle route signs on Market Street (eastbound direction) can give confusing information. J Route North continues left on Front Street. J Route left is a sub-route of Bike Route J continuing in the eastern direction.</p> <p><b>Corrective Actions:</b> Replace the bicycle route sign in the bottom left photo with the standard PennDOT M1-8 sign without the direction arrow shown below.</p>

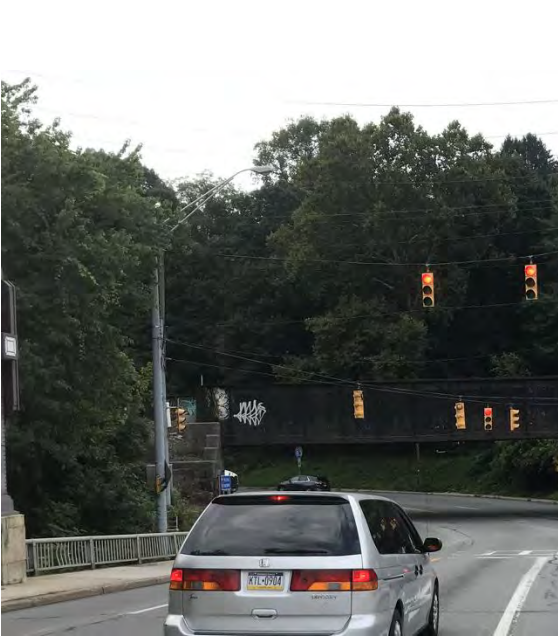
<p><b>Deficiencies:</b> The crossings are not adequately illuminated. The crossing that spans across the westbound approach is only partially illuminated on one end of the crossing (as shown in the left photo). The crossing on the southbound approach is not illuminated at all. Intersection lighting increases motorist and pedestrian visibility and reduces crash potential.</p> <p><b>Corrective Actions:</b> Install luminaires to adequately illuminate the crossings. When designing lighting, the following factors should be considered; luminaire type, light source type, wattage, mounting height, and pole location. A qualified lighting engineer should evaluate intersection lighting.</p>
