# RIVERLANDS SAFETY STUDY

HARRISBURG AREA TRANSPORTATION STUDY  
TRI-COUNTY REGIONAL PLANNING COMMISSION

JUNE 2016

**PREPARED BY:**  
WSP | PARSONS BRINCKERHOFF  
AND  
WILSON CONSULTING GROUP

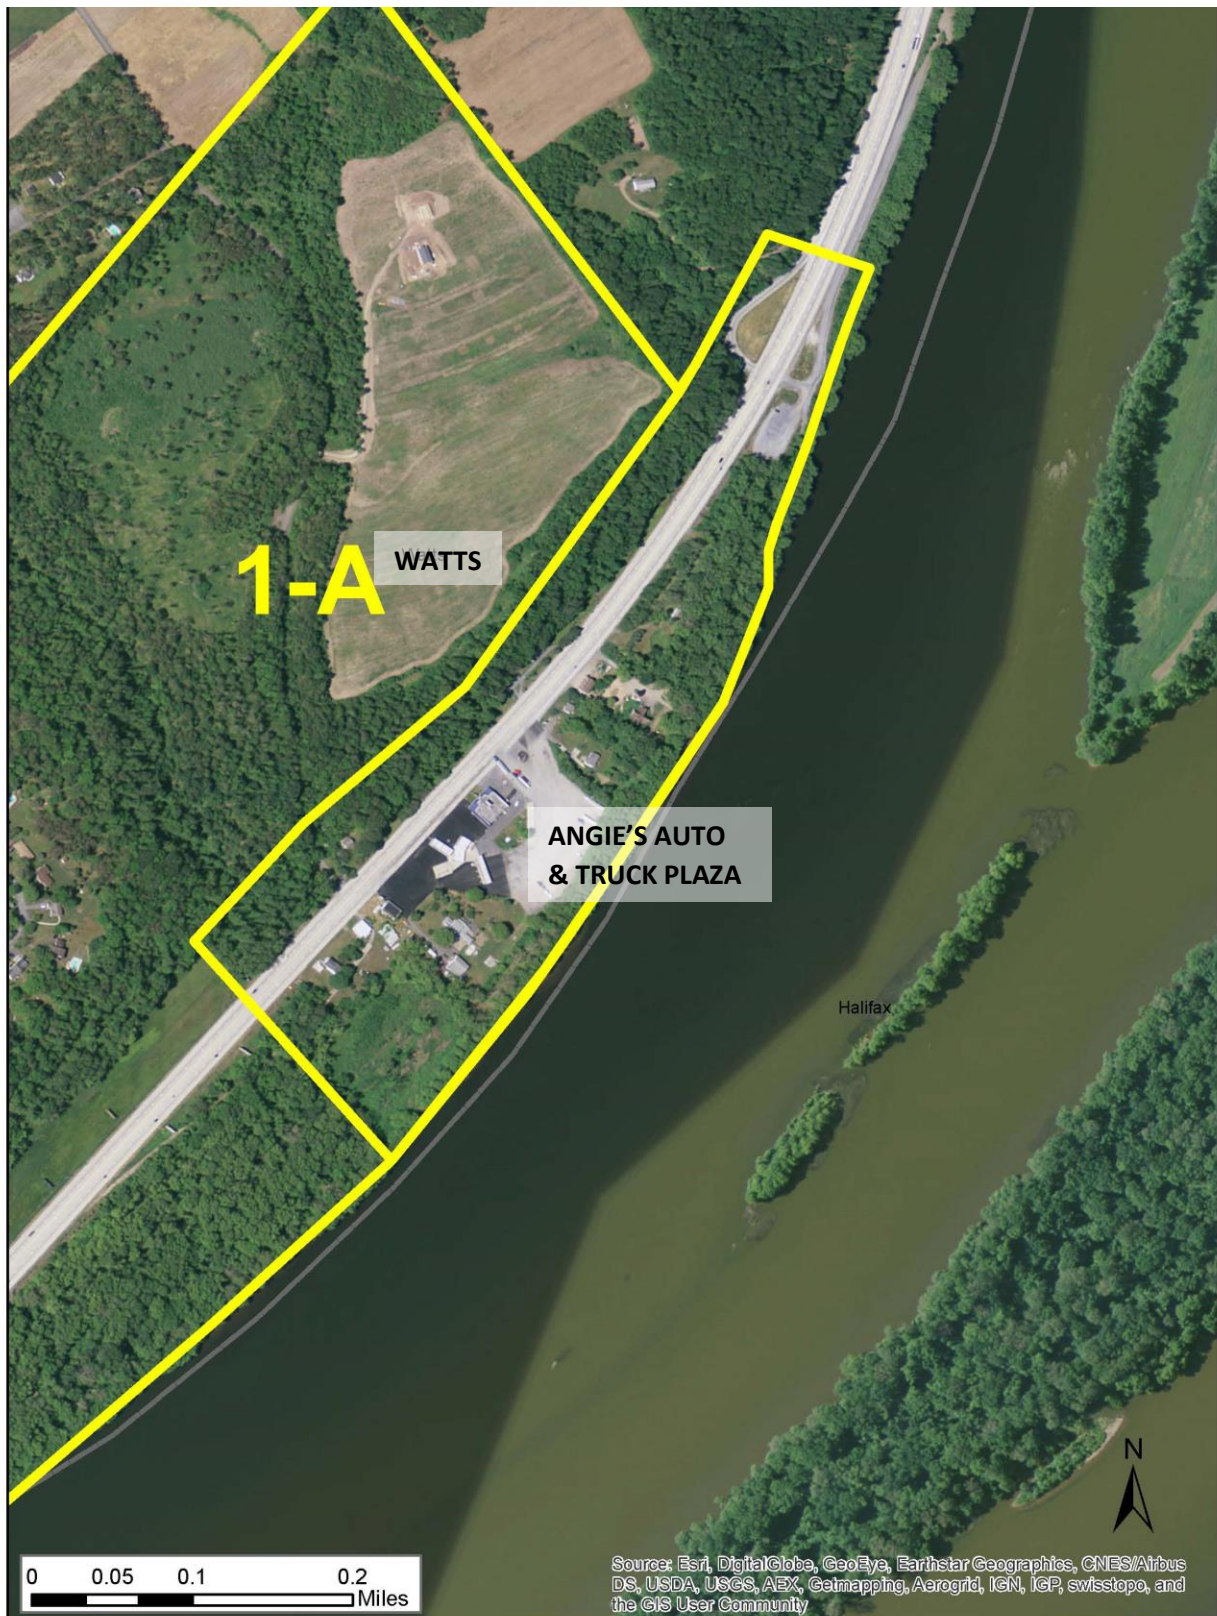
Figure 2 - Area 1-A

There are major safety concerns leading to problems within Area 1-A including multiple access points throughout the commercial stretch with limited signage, poor lighting, and sudden cross traffic.

Crash data were analyzed between the years 2010 and 2014 and the most common types of reported crashes were found to be angle crashes and motorists hitting fixed objects, each comprising 36% of the total. See the table below of the overall crash breakdown.

The contributing actions for these crashes were also analyzed, with the most common factors being improper turns (27%) and distracted driving (20%). See the table below for the overall breakdown of contributing actions. Note, there may be more than one contributing action per crash.

**RRPM, Pavement Markings and Signage:** Due to the changes in roadway characteristics upon entering Area 1-A, it is recommended that there be an increase of signage for both the westbound and eastbound approaches to warn motorists of entering vehicles and upcoming cross traffic. Along with roadway signage, more defined signs at the access points are also required. In addition to signage, recessed reflective pavement markers (RRPM) should be considered throughout the corridor to help keep vehicles in their proper lane and better alert motorists of the travel lane they are utilizing. RRPM are extremely beneficial in poorly lit areas similar to the study location.

**Lighting:** The entire study area is poorly lit, both the roadway as well as the access driveways. With the volume of cross traffic and amount of motorists utilizing the shared center turn lane, the corridor would greatly benefit from increased lighting.

**Consolidation of Access Points:** The consolidation of the existing and future access points could provide much more defined access as this portion of the overall corridor develops over time. Hardscaped, channelized turn lanes with adequate storage could be placed within the existing center turn lane. This would not only provide a safer queueing location for vehicles waiting to enter or exit the sites, but also better alert oncoming motorists of clear

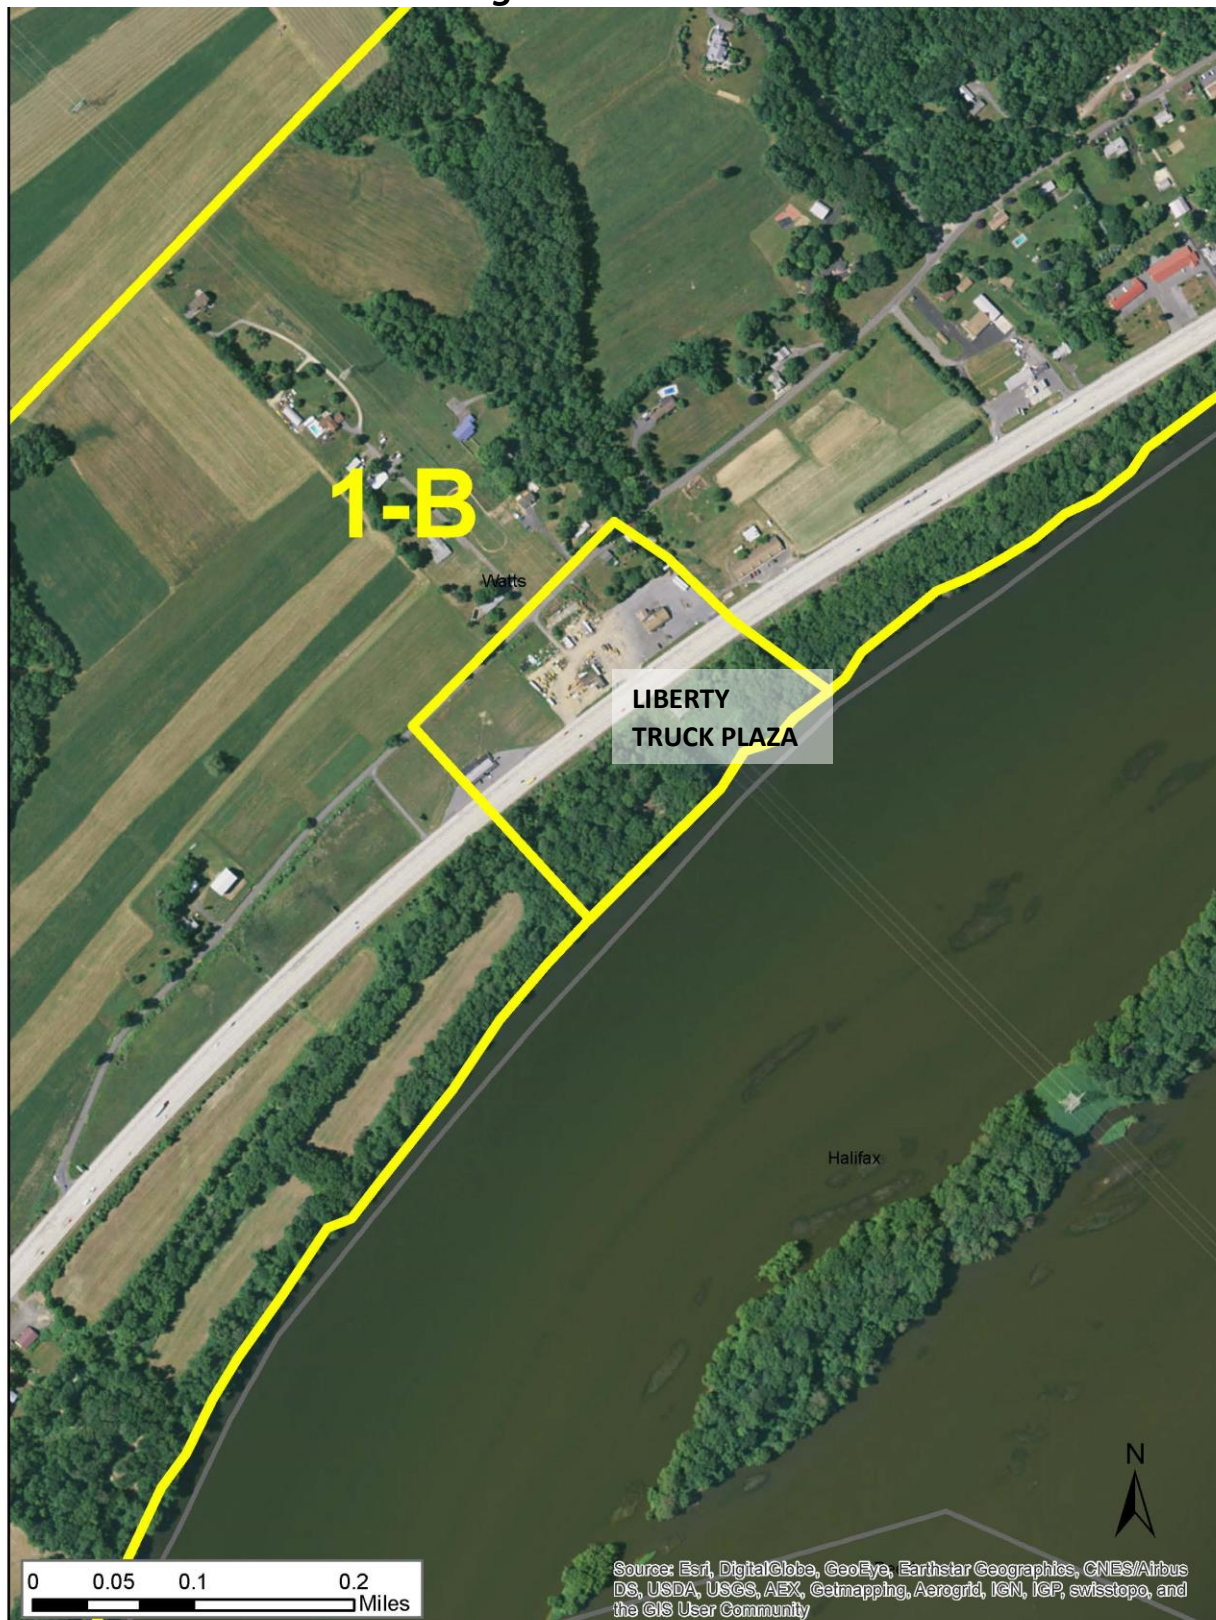
**Figure 3 - Area 1-B**

There are serious safety concerns within Area 1-B including multiple full access points throughout the commercial stretch with limited signage, poor lighting, and sudden cross traffic. The cross traffic comes as a surprise to motorists due to the change in roadway characteristics. There is minimal cross traffic both east and west of this commercial stretch. This can cause motorists to become alarmed when vehicles are entering the roadway.

As a part of the safety study, crash data was analyzed between the years 2010 and 2014. Although there were only 3 reported crashes within the study area, all of these resulted in major injury or fatality. Due to the limited number of collisions there was not a clear trend as to the contributing actions. However, it should be noted that these crashes all occurred prior to the development of the Liberty Travel Plaza.

**Consolidation of Access Points:** The consolidation of the existing and future access points as described for Section 1-A could provide much more defined access as this portion of the overall corridor develops over time. Hardscaped, channelized turn lanes with adequate storage could be placed within the existing center turn lane. This will not only provide a safer queueing location for vehicles waiting to enter or exit the sites, but also better alert oncoming motorists of clear locations of cross traffic.

**Collector Roadway:** Old Trail Road is a local roadway located behind the commercial establishments that is parallel to US 11/15 and provides access to US 11/15 just south of the Liberty Travel Plaza. Upgrading this roadway to accommodate site traffic demand and consolidate access points could help limit the number of serious crashes involving motorists attempting to access the commercial options.

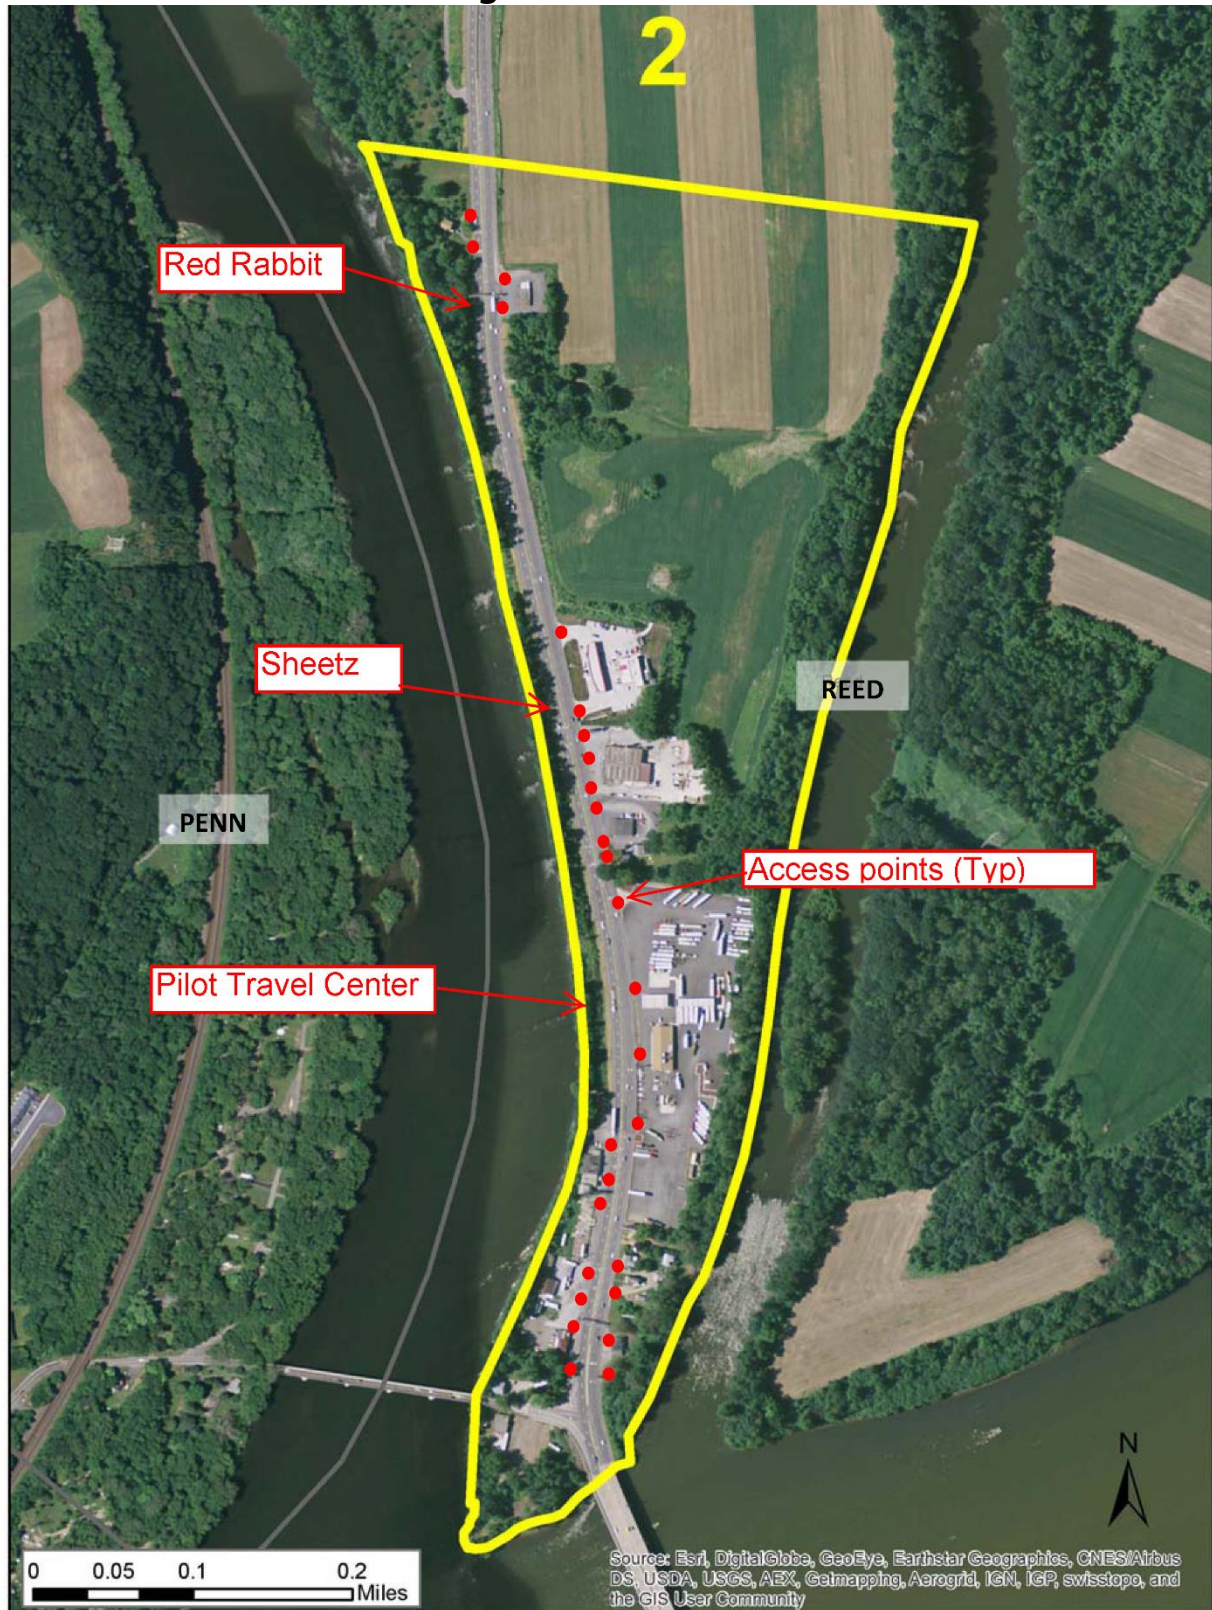
Figure 6 – Area 2

There are major safety concerns leading to problems within Area 2 including multiple access points throughout the commercial stretch with limited signage, poor lighting, sudden cross traffic, and accelerated speeds. The study team attempted to contact several property owners (Pilot, Sheetz, Red Rabbit) to ascertain their thoughts about existing safety conditions and any recommendations they may have for improving safety. As of the production of this report, no response has been provided by the property owners.

Although speed adjustment improvements have been completed by PennDOT leading into the corridor, vehicles are coming off of the Clarks Ferry Bridge and the portions of US 22/322 and US 11/15 further to the north travelling at much faster speeds than posted. This, coupled with a sudden change in roadway characteristics, is a large contributing factor to the number and type of collisions.

Crash data analyzed from 2010 through 2014 reveal that of the 78 reported crashes, the most common types are angle (59%) and rear-end (19%). See the table below of the overall crash breakdown.

The contributing actions for these crashes were also analyzed, with the most common factors being improper turns (59%), careless driving (13%), and speeding (8%). Although the data is not representative of the speeding issue, it is assumed that if the speed were to be monitored more frequently that there would be a decrease in the aforementioned contributing actions. The large number of businesses and access points along this section of roadway does provide a number of potential locations for police to monitor speed conditions, especially for westbound traffic. See the table below for the overall contributing actions breakdown.

**RRPM, Pavement Markings and Signage:** Due to the changes in roadway characteristics upon entering Area 2, it is recommended that there be an increase of signage for both the westbound and eastbound approaches to warn motorists of entering vehicles and upcoming cross traffic. Along with roadway signage, more defined signs at the access points are also needed. In addition to signage, recessed reflective pavement markers (RRPM) should be considered throughout corridor to help keep vehicles in their proper lane and better alert motorists of the travel lane they are using. RRPM are extremely beneficial in poorly lit areas similar to the study location. Although Area 2 was recently repaved and striped (2015), there are many opportunities for increased striping to help further enforce the speed change that occurs entering and exiting the corridor.

**Median Barrier:** As previously mentioned, the highest percentage of crashes that occur in Area 2 are of the angle type, the majority of which are caused by vehicles turning left to enter or exit business establishments. There are 27 points of access within the approximately 4,000-foot corridor available to motorists via a shared center left turn lane (See Figure 6). While a median barrier would eliminate access to the many businesses in this section for eastbound traffic and force any drivers wishing to exit the businesses travelling eastbound to utilize the nearby interchange, the design and construction of a concrete glare screen barrier would eliminate the left-turn issue and greatly lessen the number of crashes.

**Lighting:** The entire study area is poorly lit, both the roadway as well as the access driveways. Despite 65% of the crashes in Area 2 occurring during daylight, roadway lighting is strongly recommended. It is common practice to incorporate lighting along corridors that differ from the typical section of roadway, which is the case in this situation. With the volume of cross traffic and amount of motorists utilizing the shared center turn lane, corridor safety would greatly benefit from increased lighting.

**Advanced Congestion Electronic System (ACES):** ACES consists of variable message sign activated detectors in the roadway within the study area that alert approaching motorists of excessively slow speeds or congestion ahead. This should assist in lowering the number of rear-end collisions.

**Consolidation of Access Points:** As mentioned above, there are 27 points of access within the approximately 4,000-foot corridor available to motorists via a shared center left turn lane. The consolidation of these could provide much more defined access to the commercial establishments throughout the corridor. While it would require longer design and construction time than the barrier proposed as a short-term alternative, hardscaped, channelized turn lanes with adequate storage could be placed within the existing center turn lane. This will not only provide a safer queueing location for vehicles waiting to enter or exit the sites, but also better alert oncoming motorists of clear locations of cross traffic. It would also provide some opportunity for eastbound traffic to access the businesses along the east side of the roadway.

**Additional Turn Lane:** The entrance to the Pilot Travel Center is located in the eastern portion of the study area within close proximity to the Clarks Ferry Bridge. Truck drivers travelling westbound entering the site are forced to decelerate rapidly causing westbound traffic to nearly come to a stop, backing up onto the bridge. There is currently a full width shoulder along the westbound travel lanes. Converting this shoulder into an ingress/egress lane throughout the corridor would provide a deceleration lane for westbound vehicles entering the sites. In addition, it could also function as an acceleration lane for those vehicles exiting and merging with westbound traffic.

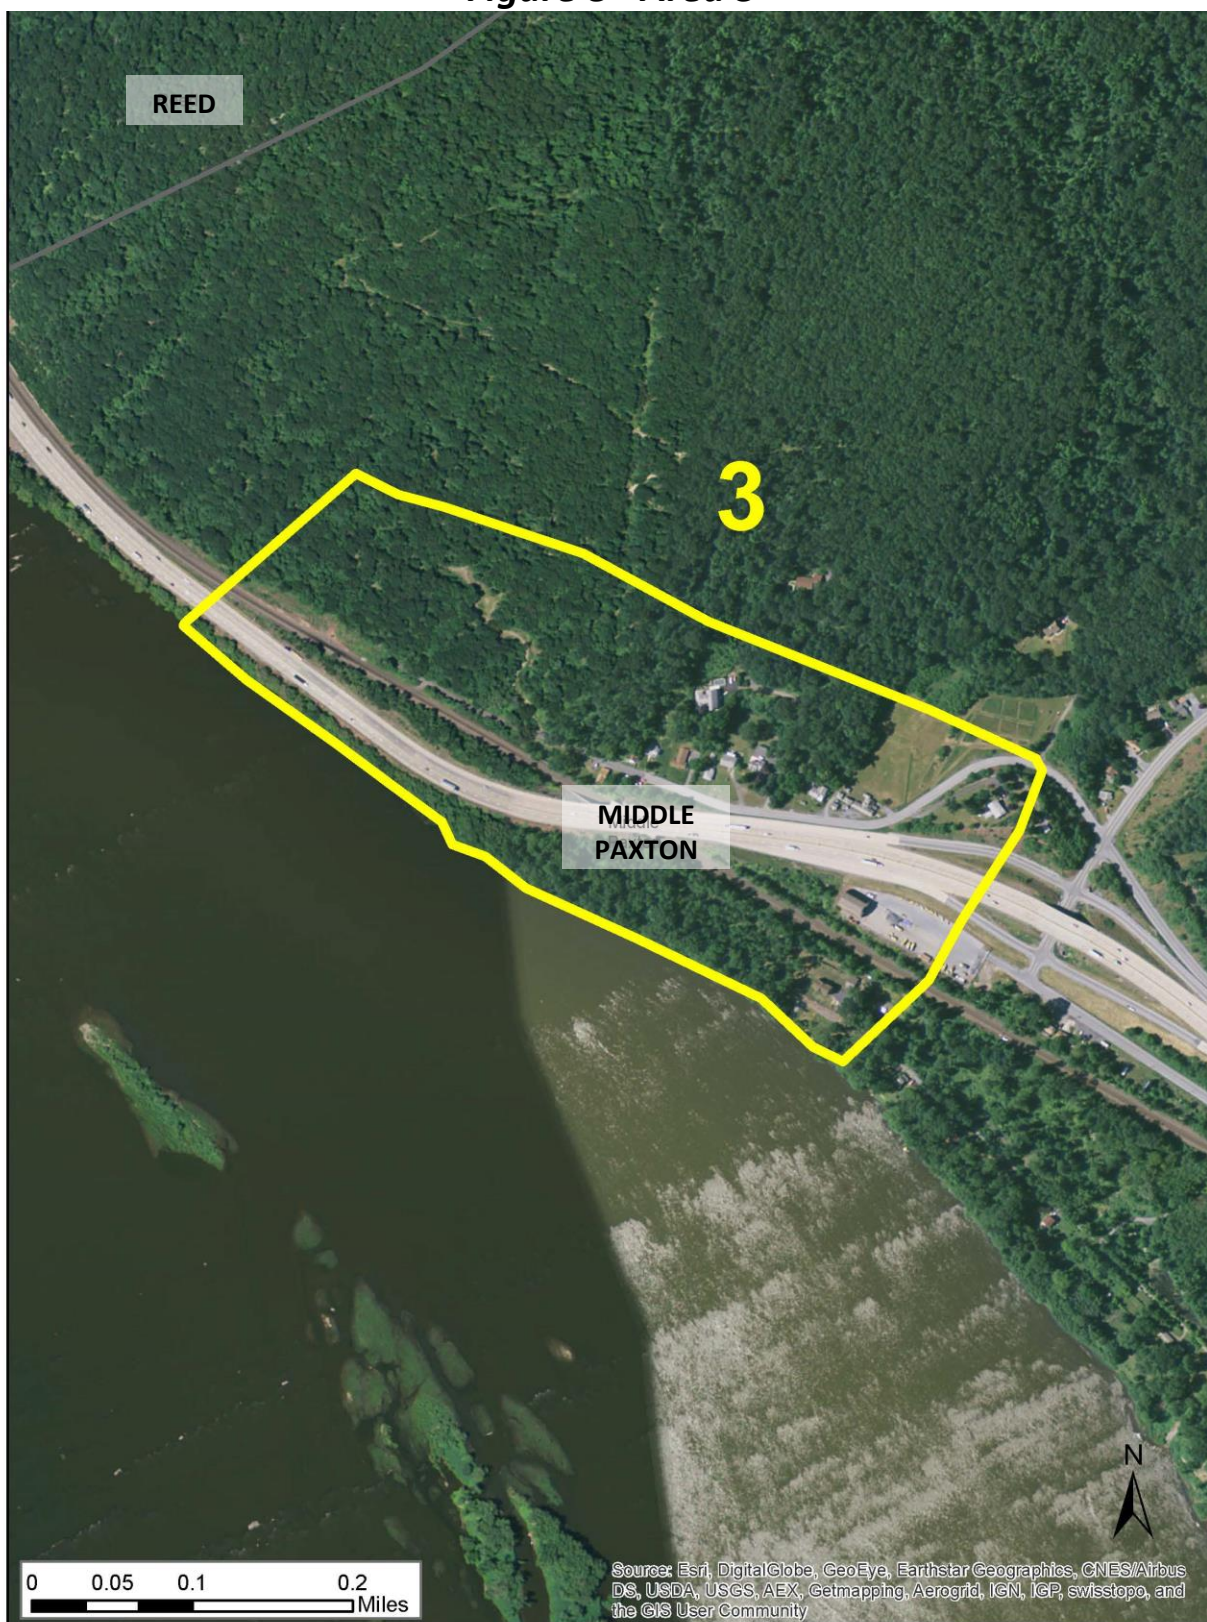
**Figure 8 - Area 3**

Throughout Area 3, missing lane delineation, overall lack of interchange lighting, and accelerated speeds all contribute to the safety concerns.

Of the 29 reported crashes between the years 2010 to 2014, the most common type is motorists hitting fixed objects (62%). Compared to other segments of US 22/322, the overall volume of collisions is not excessive, however the number of crashes that resulted in a major injury or fatality reach 10% of the total crashes. See the table below for a summary of existing safety conditions.

**RRPM:** Due to the curvature in roadway throughout Area 3, it is recommended that recessed reflective pavement markers (RRPM) should be considered throughout corridor to help keep vehicles on the roadway and within their proper lane. RRPM are extremely beneficial in assisting motorists maneuver curves at higher speeds in poorly lit areas similar to the study location. RRPM being implemented within the study area has the potential to decrease the volume of angle and same direction sideswipe collisions in the future.

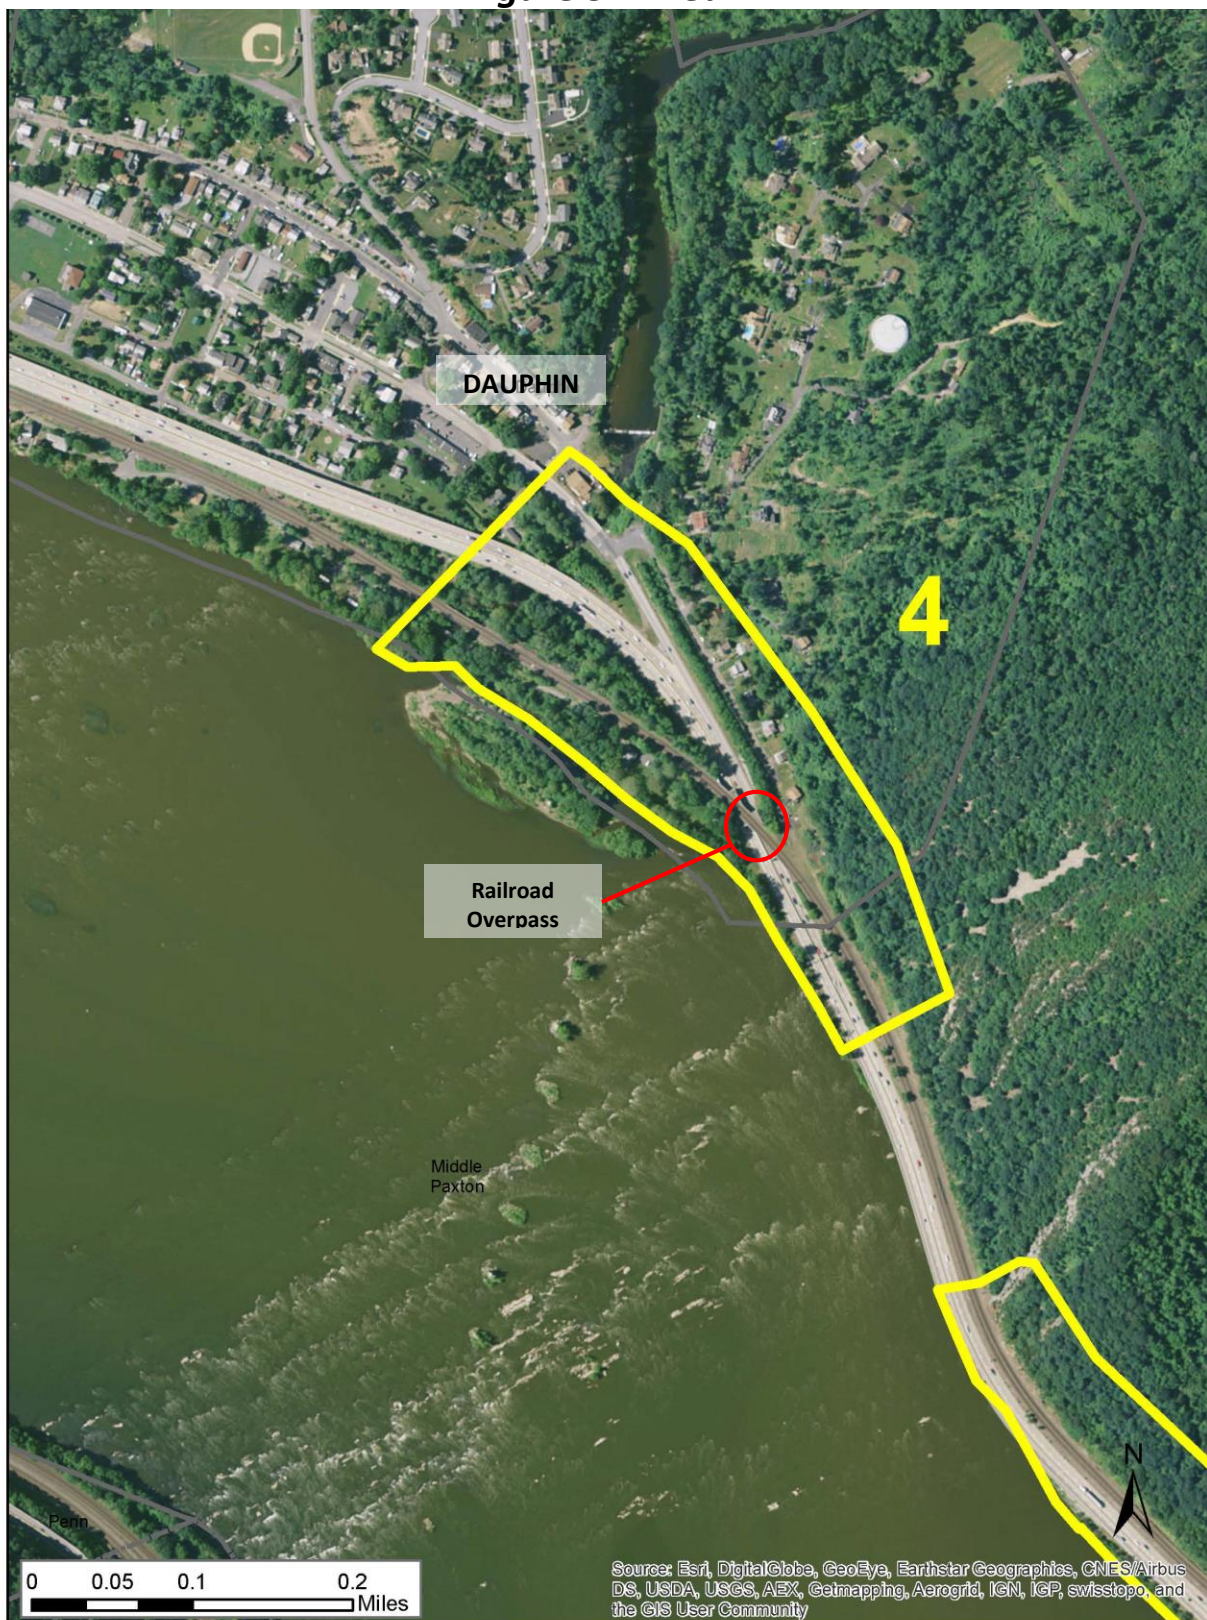
**Figure 9 - Area 4**

Within Area 4 there is a railroad overpass which creates a tunnel effect for both the west and eastbound traffic. The eastbound motorists are traveling through a curve in the roadway and enter under the ill-lit and poorly delineated railroad overpass. In addition to the lighting and delineation issues there are damaged roadway features throughout the corridor including guiderail terminations and roadway conditions.

As a part of the safety study, crash data were analyzed between the years 2010 and 2014. Of the 44 reported crashes, the most common type are motorists hitting fixed objects (71%). Although a number of crashes occur in the direct vicinity of the overpass there is no indication the clearance height is an issue. It should be noted that 73% of the reported collisions occur in the eastbound travel lanes. See the table below of the overall crash breakdown.

In addition to the types of crashes, any trending factors within the data were analyzed. It was discovered that 84% of the crashes in Area 4 occurred while the roadway was either wet, icy, slushy or snow covered. This could be a result of poor drainage due to the elevation of the inverts within the stormwater drainage system in reference to the height of the Susquehanna River, especially under flooding conditions. Historically as the river rises, water is pushed back into the drainage system, which then overflows onto the roadway. During the April 2016 field view to discuss this report's preliminary findings, township officials noted that during extreme flooding events that US 22/322 has been completely shut down in this location due to the depth of water on the roadway. The study team reached out to Susquehanna River Basin Commission and they shared the following: "the flooding impacts along 322 at the railroad underpass are due to the crest elevation of the Susquehanna River during a major flood event. A major flood event typically equates to a 100-year storm event. When the Susquehanna River crests above 23.0' the water will begin to flood the railroad underpass along US 22/322. In the past 20 years the Susquehanna River has crested above 23.0' (major flood event) 4 times (1996, 1996, 2004, 2011)." Additionally, the bridge over Stony Creek is not delineated and signed as a bridge and motorists are likely unaware of the potential icing during freezing conditions. Refer to the table below of the overall roadway crash condition breakdown.

Another trend observed was that speed was a factor in 66% of the crashes. See the table below for an overall breakdown of the contributing factors. These data indicate that increased speed enforcement in this area could have a significant impact in reducing overall crashes. The Route 225 on-ramp to US 22/322 eastbound provides the most likely location for eastbound speed enforcement in this area. The railroad overpass in the southern portion of this area significantly limits westbound speed monitoring opportunities for westbound traffic in the immediate vicinity. Westbound speed monitoring may have to take place as indicated for Area 5.

**RRPM, Pavement Markings and Signage:** Due to the curvature of the roadway and overpass/ramp locations, increased signing, striping and recessed reflective pavement markers (RRPM) could help keep motorists in the correct lane and on the roadway. In addition to pavement markings, signage informing traffic of narrowing roadway conditions and structures could help lower the volume of crashes.

**Roadway Improvements:** As previously mentioned, there is damaged roadway throughout the corridor. There are issues with the settlement of the roadway in the eastbound and westbound travel lanes causing a rollercoaster effect. Improvements to the subbase layer of roadway would be needed to improve these conditions.

**Drainage Assessment:** As previously mentioned, 84% of the crashes in Area 4 occurred while the roadway was either wet, icy, slushy or snow covered and could be a result of a poor drainage system. A detailed assessment of existing drainage conditions and alternatives for drainage improvements should be conducted and implemented.

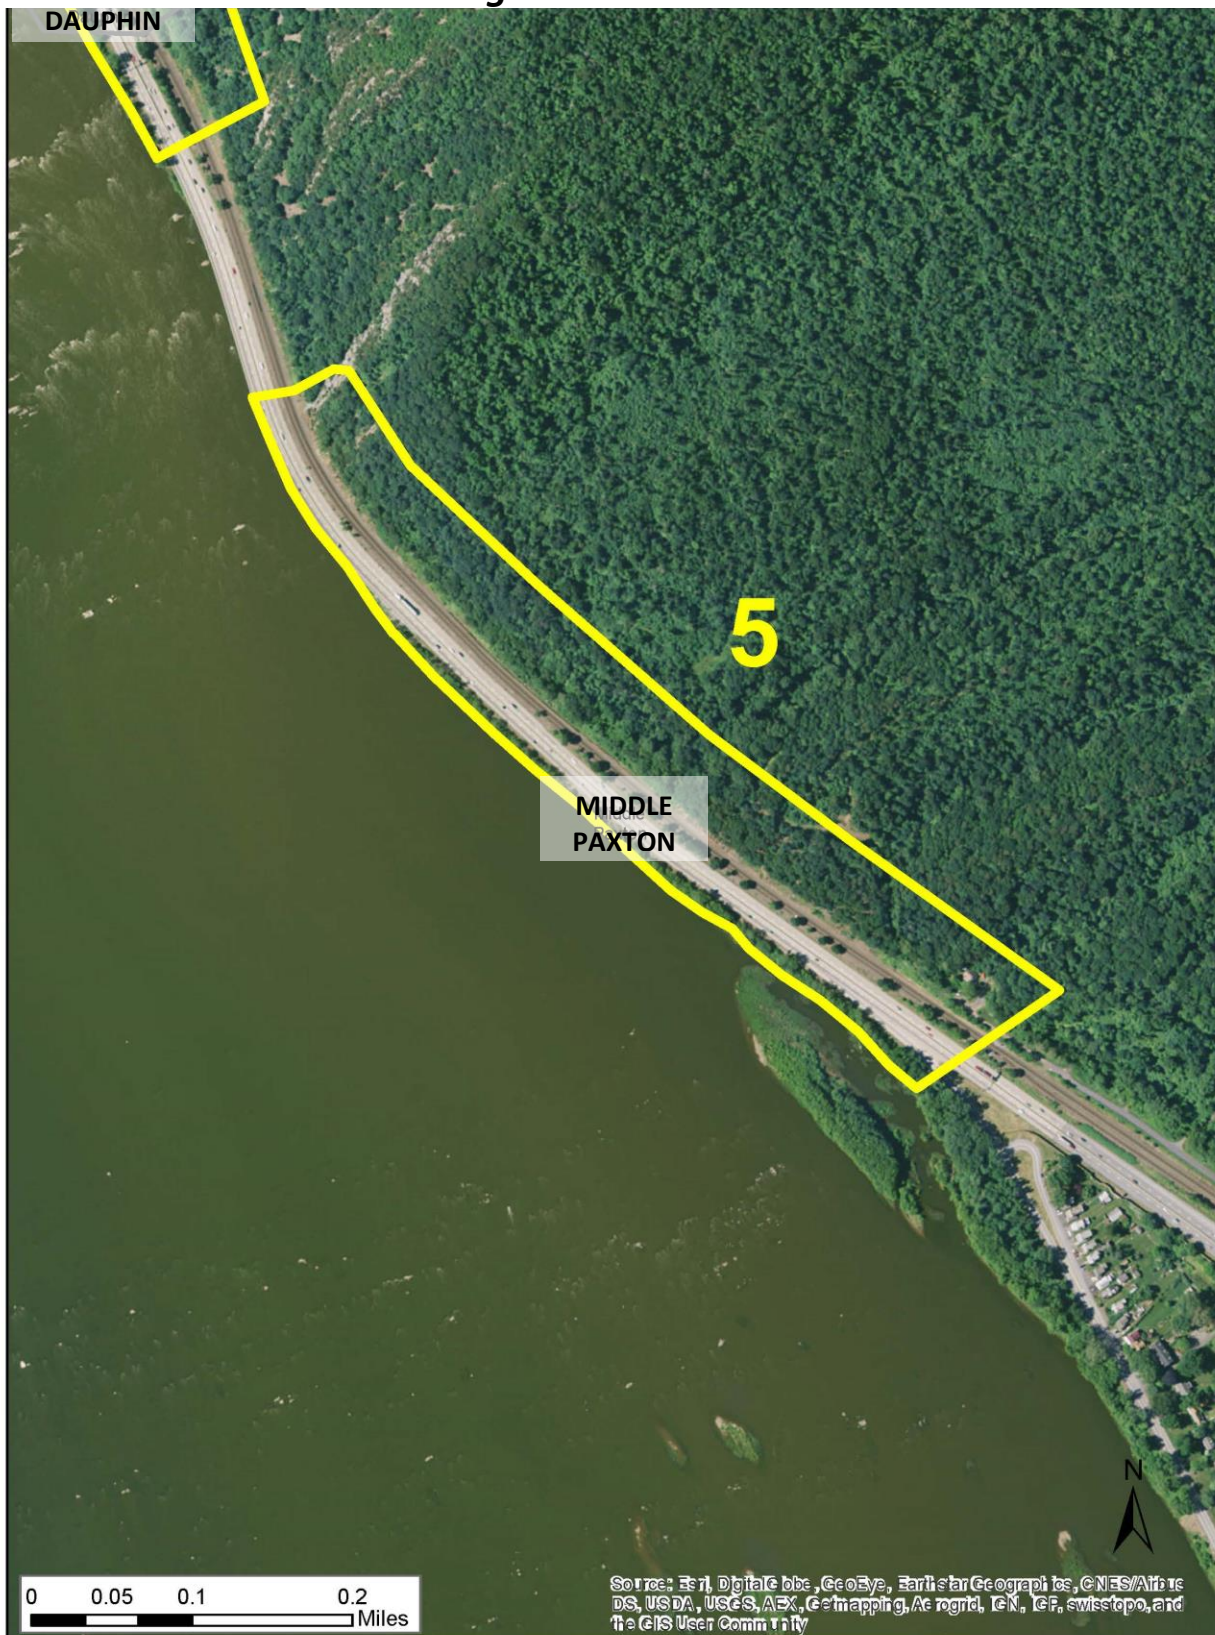
*Figure 10 - Area 5*

One of the biggest issues in Area 5 is the deteriorated state of a retaining wall along the westbound travel lanes. Beneath the crumbling stone wall is a lateral drainage system stretching the length of the wall. The existing wall is not properly protecting the drainage system from debris such as branches, leaves and other material sliding down the slope towards the roadway. This debris causes drainage problems and could be effecting the functionality of the entire drainage system, potentially causing safety hazards for motorists and cyclists. Additionally, rocks and other debris are periodically found on and along the roadway, potentially contributing to fixed object and other crashes.

Lastly, participants in the field view noted that poorly lit and limited signage in the area of North Front Street has led to some drivers inadvertently entering Route 22/322 in the wrong direction in the eastbound lanes.

**Reconstruction of Retaining Wall:** Due to the state of the retaining wall, it is proposed to reconstruct the approximately 2,000 linear foot wall. It is also recommended that a rock catch fence be constructed on top of the retaining wall which could provide a higher level of protection from debris falling onto the roadway. Being that the most common crash type within the study area is the hitting of fixed objects, this percentage is anticipated to decrease by limiting the amount of objects in the travel lanes.

**Drainage Assessment/Improvement:** As previously mentioned, the linear drainage system is currently covered with debris from the hillside, which slopes down to the retaining wall. Therefore, the exact condition of the drainage system is unknown. It is recommended that the drainage system be cleaned out after the retaining wall is reconstructed and its condition evaluated and improved as necessary. Of the reported crashes within Area 5, 53% occurred when the roadway was either wet, slushy, icy or snow covered.

**RRPM, Delineation, Glare Screen:** Recessed reflective pavement markers (RRPM) should be considered throughout the corridor to help keep vehicles in their proper lane and better alert motorists of the travel lane they are using. In conjunction with RRPM, given the nature of the majority of the collisions, side mounted delineation is recommended, as well as the addition of a vertical blade glare screen.
