RIVERLANDS SAFETY STUDY

HARRISBURG AREA TRANSPORTATION STUDY TRI-COUNTY REGIONAL PLANNING COMMISSION

AUGUST 2016

PREPARED BY: WSP | PARSONS BRINCKERHOFF AND WILSON CONSULTING GROUP

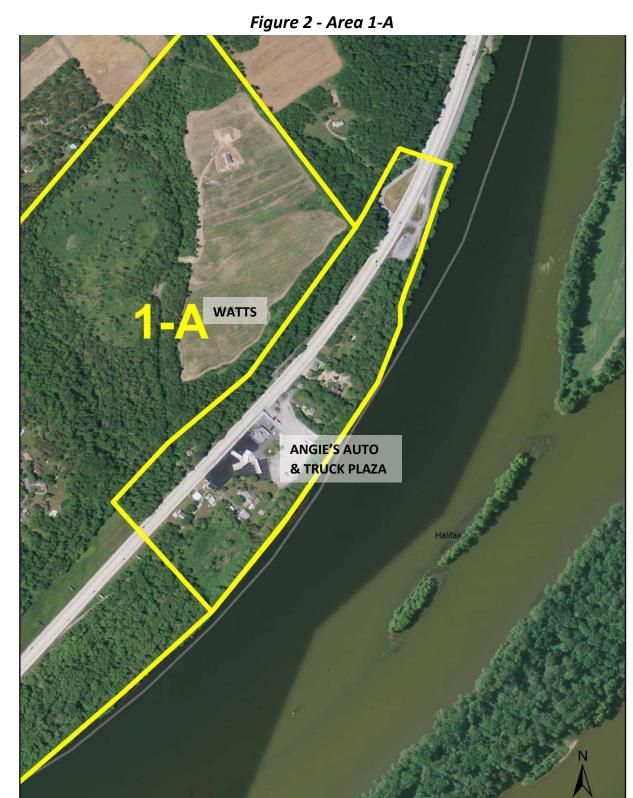
AREA 1-A

There are major safety concerns leading to problems within Area 1-A including multiple access points throughout the commercial stretch with limited signage, poor lighting, and sudden cross traffic.

RRPM, **Pavement Markings and Signage**: Due to the changes in roadway characteristics upon entering Area 1-A, it is recommended that there be an increase of signage for both the westbound and eastbound approaches to warn motorists of entering vehicles and upcoming cross traffic. Along with roadway signage, more defined signs at the access points are also required. In addition to signage, recessed reflective pavement markers (RRPM) should be considered throughout the corridor to help keep vehicles in their proper lane and better alert motorists of the travel lane they are utilizing. RRPM are extremely beneficial in poorly lit areas similar to the study location.

Lighting: The entire study area is poorly lit, both the roadway as well as the access driveways. With the volume of cross traffic and amount of motorists utilizing the shared center turn lane, the corridor would greatly benefit from increased lighting.

Consolidation of Access Points: The consolidation of the existing and future access points could provide much more defined access as this portion of the overall corridor develops over time. Hardscaped, channelized turn lanes with adequate storage could be placed within the existing center turn lane. This would not only provide a safer queueing location for vehicles waiting to enter or exit the sites, but also better alert oncoming motorists of clear

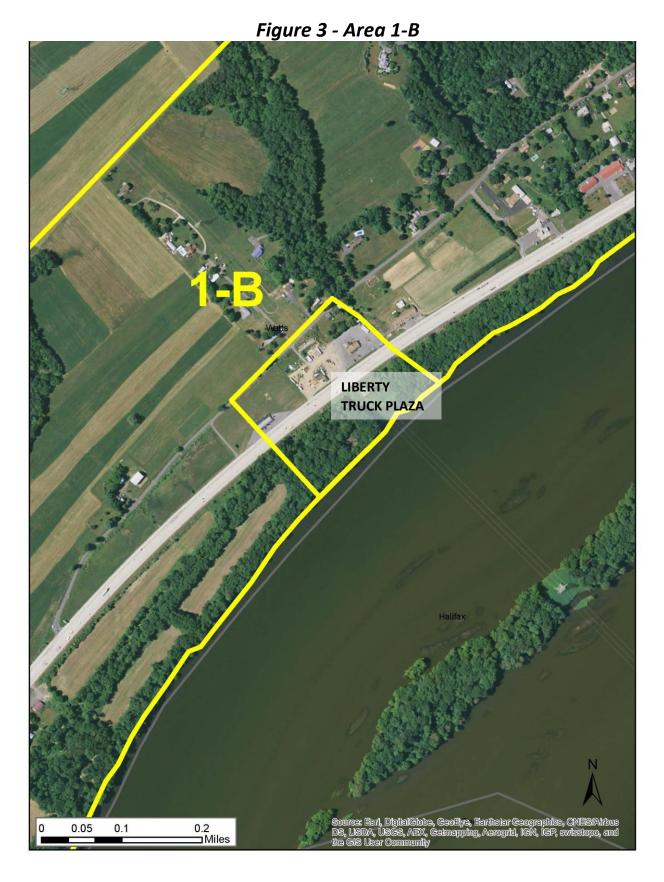
AREA 1-B

There are serious safety concerns within Area 1-B including multiple full access points throughout the commercial stretch with limited signage, poor lighting, and sudden cross traffic. The cross traffic comes as a surprise to motorists due to the change in roadway characteristics. There is minimal cross traffic both east and west of this commercial stretch. This can cause motorists to become alarmed when vehicles are entering the roadway.

Consolidation of Access Points: The consolidation of the existing and future access points as described for Section 1-A could provide much more defined access as this portion of the overall corridor develops over time. Hardscaped, channelized turn lanes with adequate storage could be placed within the existing center turn lane. This will not only provide a safer queueing location for vehicles waiting to enter or exit the sites, but also better alert oncoming motorists of clear locations of cross traffic.

Collector Roadway: Old Trail Road is a local roadway located behind the commercial establishments that is parallel to US 11/15 and provides access to US 11/15 just south of the Liberty Travel Plaza. Upgrading this roadway to accommodate site traffic demand and consolidate access points could help limit the number of serious crashes involving motorists attempting to access the commercial options.

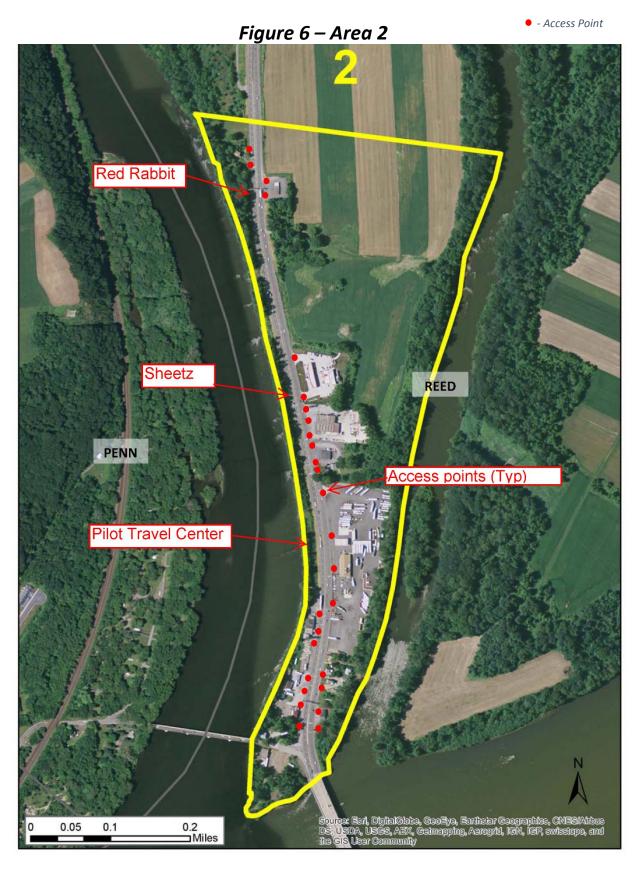
AREA 2

There are major safety concerns leading to problems within Area 2 including multiple access points throughout the commercial stretch with limited signage, poor lighting, sudden cross traffic, and accelerated speeds. The study team attempted to contact several property owners (Pilot, Sheetz, Red Rabbit) to ascertain their thoughts about existing safety conditions and any recommendations they may have for improving safety. As of the production of this report, no response has been provided by the property owners.

Although speed adjustment improvements have been completed by PennDOT leading into the corridor, vehicles are coming off of the Clarks Ferry Bridge and the portions of US 22/322 and US 11/15 further to the north travelling at much faster speeds than posted. This, coupled with a sudden change in roadway characteristics, is a large contributing factor to the number and type of collisions.

RRPM, **Pavement Markings and Signage**: Due to the changes in roadway characteristics upon entering Area 2, it is recommended that there be an increase of signage for both the westbound and eastbound approaches to warn motorists of entering vehicles and upcoming cross traffic. Along with roadway signage, more defined signs at the access points are also needed. In addition to signage, recessed reflective pavement markers (RRPM) should be considered throughout corridor to help keep vehicles in their proper lane and better alert motorists of the travel lane they are using. RRPM are extremely beneficial in poorly lit areas similar to the study location. Although Area 2 was recently repaved and striped (2015), there are many opportunities for increased striping to help further enforce the speed change that occurs entering and exiting the corridor.

Median Barrier: As previously mentioned, the highest percentage of crashes that occur in Area 2 are of the angle type, the majority of which are caused by vehicles turning left to enter or exit business establishments. There are 27 points of access within the approximately 4,000-foot corridor available to motorists via a shared center left turn lane (See Figure 6). While a median barrier would eliminate access to the many businesses in this section for eastbound traffic and force any drivers wishing to exit the businesses travelling eastbound to utilize the nearby interchange, the design and construction of a concrete glare screen barrier would eliminate the left-turn issue and greatly lessen the number of crashes.

Lighting: The entire study area is poorly lit, both the roadway as well as the access driveways. Despite 65% of the crashes in Area 2 occurring during daylight, roadway lighting is strongly recommended. It is common practice to incorporate lighting along corridors that differ from the typical section of roadway, which is the case in this situation. With the volume of cross traffic and amount of motorists utilizing the shared center turn lane, corridor safety would greatly benefit from increased lighting.

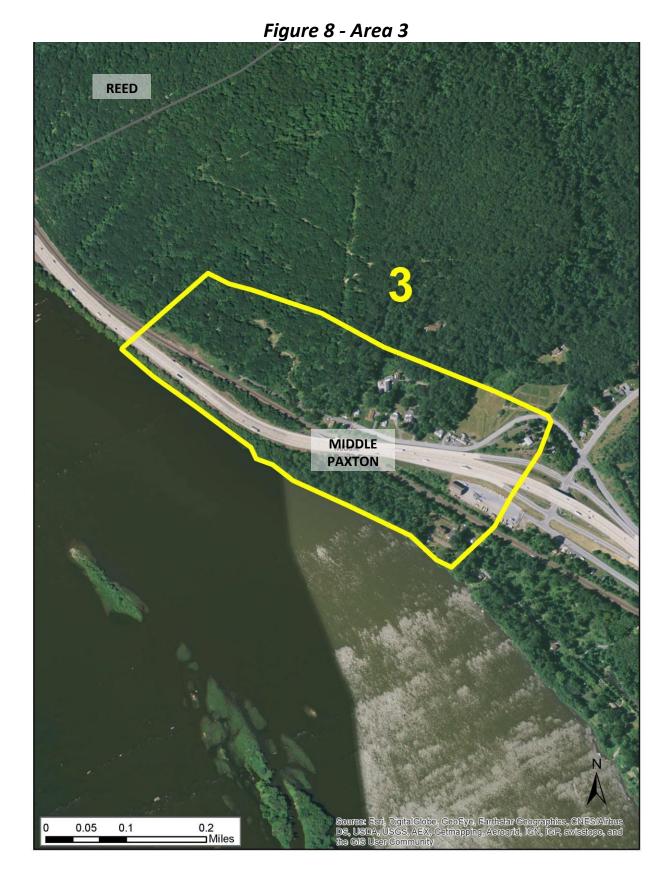
AREA 3

Throughout Area 3, missing lane delineation, overall lack of interchange lighting, and accelerated speeds all contribute to the safety concerns.

RRPM: Due to the curvature in roadway throughout Area 3, it is recommended that recessed reflective pavement markers (RRPM) should be considered throughout corridor to help keep vehicles on the roadway and within their proper lane. RRPM are extremely beneficial in assisting motorists maneuver curves at higher speeds in poorly lit areas similar to the study location. RRPM being implemented within the study area has the potential to decrease the volume of angle and same direction sideswipe collisions in the future.

Reflective Markers: There is a lack of adequate lane delineation within the study area. Very similar to the RRPM, reflective markers placed along the top of the barrier greatly assist motorists to properly traverse the corridor. The implementation of reflective markers should decrease the number of motorists hitting fixed objects.

Lighting: The entire study area is poorly lit, both the roadway as well as entrance and exit ramps. With the location of the exit and entrance ramps in relation to the roadway curvature, increased lighting could greatly increase the safety and operation of the interchange. Poor lighting at the nearby intersection with Gap View Road should also be evaluated alongside the issues associated directly with the interchange.

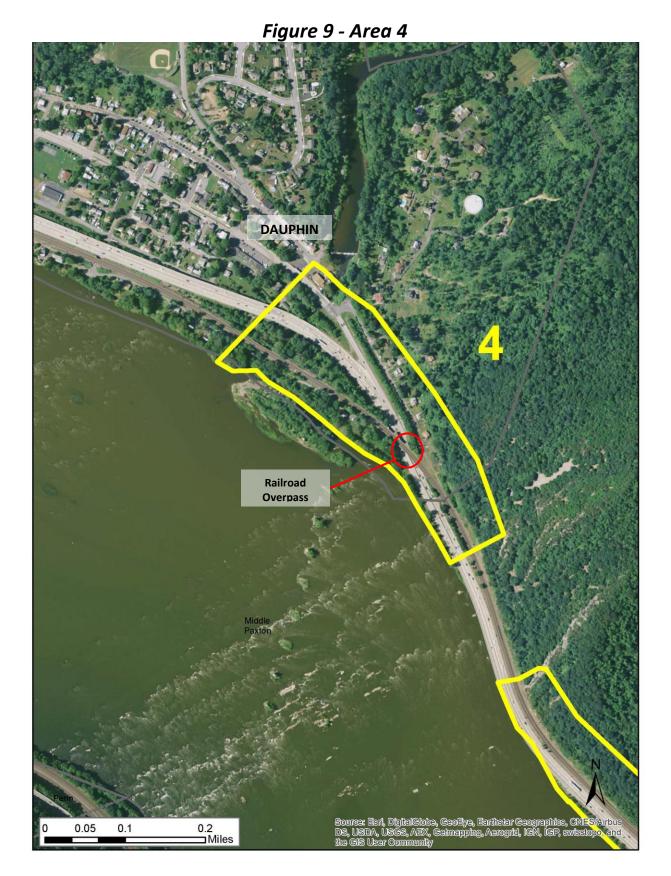
AREA 4

Within Area 4 there is a railroad overpass which creates a tunnel effect for both the west and eastbound traffic. The eastbound motorists are traveling through a curve in the roadway and enter under the ill-lit and poorly delineated railroad overpass. In addition to the lighting and delineation issues there are damaged roadway features throughout the corridor including guiderail terminations and roadway conditions.

RRPM, **Pavement Markings and Signage:** Due to the curvature of the roadway and overpass/ramp locations, increased signing, striping and recessed reflective pavement markers (RRPM) could help keep motorists in the correct lane and on the roadway. In addition to pavement markings, signage informing traffic of narrowing roadway conditions and structures could help lower the volume of crashes.

Lighting: The entire study area is poorly lit, both the roadway as well as the westbound exit ramp. With the location of the ramp in relation to the railroad overpass and roadway curvature, increased lighting could greatly improve the safety and operation of the interchange. There was temporary lighting installed at the Dauphin exit which has since been removed. Consideration should be given to the installation of permanent LED lighting in this location.

Guiderail Improvements: The guiderail at the westbound exit into Dauphin Borough, although seemingly reconstructed, could benefit from delineation and a new end treatment. As it stands, 30% (13) of the crashes in the westbound direction are vehicles colliding with the guiderail.

Roadway Improvements: As previously mentioned, there is damaged roadway throughout the corridor. There are issues with the settlement of the roadway in the eastbound and westbound travel lanes causing a rollercoaster effect. Improvements to the subbase layer of roadway would be needed to improve these conditions.

Drainage Assessment: As previously mentioned, 84% of the crashes in Area 4 occurred while the roadway was either wet, icy, slushy or snow covered and could be a result of a poor drainage system. A detailed assessment of existing drainage conditions and alternatives for drainage improvements should be conducted and implemented.

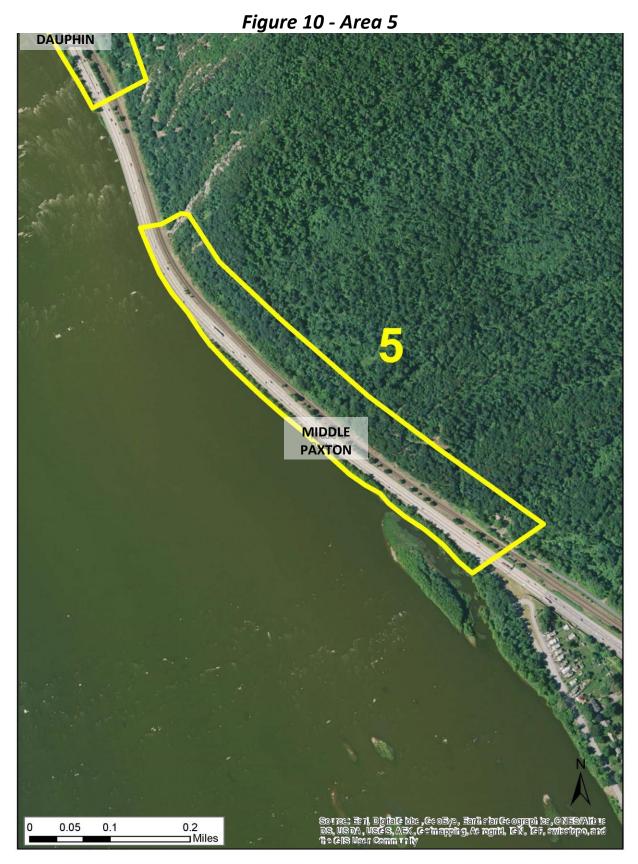
AREA 5

One of the biggest issues in Area 5 is the deteriorated state of a retaining wall along the westbound travel lanes. Beneath the crumbling stone wall is a lateral drainage system stretching the length of the wall. The existing wall is not properly protecting the drainage system from debris such as branches, leaves and other material sliding down the slope towards the roadway. This debris causes drainage problems and could be effecting the functionality of the entire drainage system, potentially causing safety hazards for motorists and cyclists. Additionally, rocks and other debris are periodically found on and along the roadway, potentially contributing to fixed object and other crashes.

Reconstruction of Retaining Wall: Due to the state of the retaining wall, it is proposed to reconstruct the approximately 2,000 linear foot wall. It is also recommended that a rock catch fence be constructed on top of the retaining wall which could provide a higher level of protection from debris falling onto the roadway. Being that the most common crash type within the study area is the hitting of fixed objects, this percentage is anticipated to decrease by limiting the amount of objects in the travel lanes.

Drainage Assessment/Improvement: As previously mentioned, the linear drainage system is currently covered with debris from the hillside, which slopes down to the retaining wall. Therefore, the exact condition of the drainage system is unknown. It is recommended that the drainage system be cleaned out after the retaining wall is reconstructed and its condition evaluated and improved as necessary. Of the reported crashes within Area 5, 53% occurred when the roadway was either wet, slushy, icy or snow covered.

RRPM, **Delineation**, **Glare Screen**: Recessed reflective pavement markers (RRPM) should be considered throughout the corridor to help keep vehicles in their proper lane and better alert motorists of the travel lane they are using. In conjunction with RRPM, given the nature of the majority of the collisions, side mounted delineation is recommended, as well as the addition of a vertical blade glare screen.
