# MARKET STREET BICYCLE/PEDESTRIAN ACCOMMODATION STUDY

Harrisburg Area Transportation Study

## 2 ROADSIDE SAFETY AUDIT

### 2.1 Existing Conditions and Deficiencies

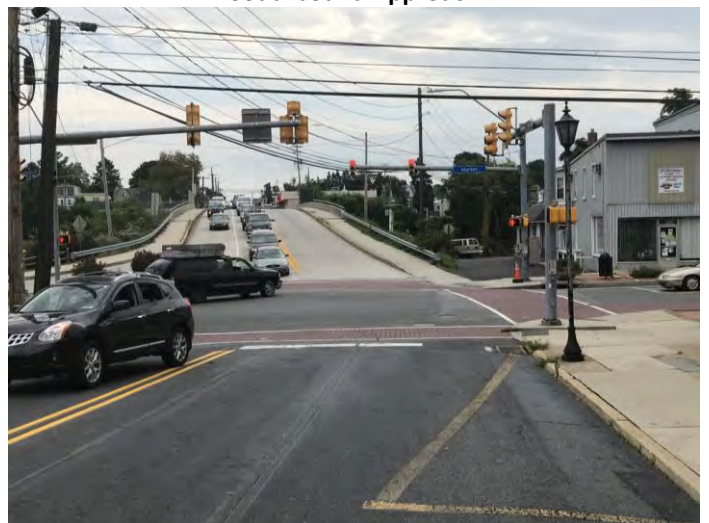
Southbound Approach

Photo	Deficiency/Corrective Action
 	<p><b>Deficiencies:</b>                  Many of the signs on Market Street are obstructed by trees along the roadway. This can prevent motorists from reading them. Additionally, the trees can limit sight distance for vehicles exiting the driveways along Market Street.</p> <p><b>Corrective Actions:</b>                  Remove the trees to remove the obstructions.</p>
 	<p><b>Deficiencies:</b>                  There is a bicycle route sign that indicates Route J2 ends, but there is no bicycle route sign for Route J which runs along the south and east legs of the intersection.</p> <p><b>Corrective Actions:</b>                  Install a bicycle route sign on a separate post to denote the beginning of Route J.</p>

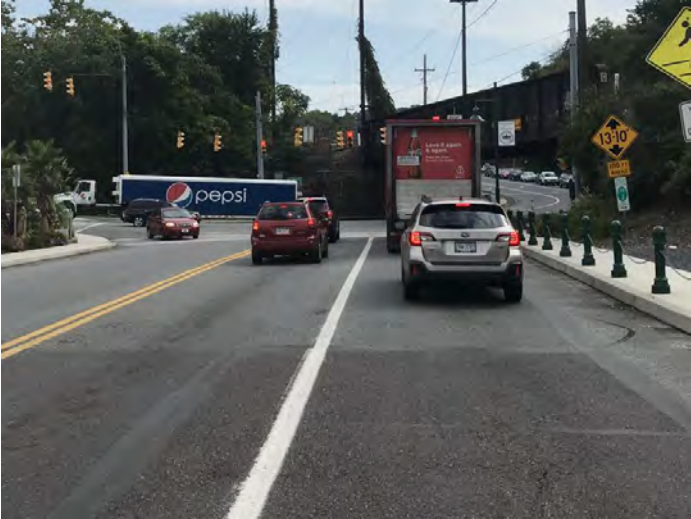
Southbound Approach

<p><b>Deficiencies:</b> Many of the signs use Type I sheeting. All regulatory, warning, and guide signs with a green background should utilize Type III or higher sheeting as stated in section 2A.08 of the DoD Supplement to the MUTCD. This sheeting provides levels of retroreflectivity to ensure the signs can be seen during nighttime or low-light conditions.</p> <p>Refer to Section 2A.08 of the CA MUTCD for standards and guidance relating to maintaining minimum retroreflectivity. The Federal Highway Administration (FHWA) also provides a retroreflective sheeting guide to help identify sheeting types: <a href="https://safety.fhwa.dot.gov/roadway_dept/night_visib/sign_visib/sheetguide/">https://safety.fhwa.dot.gov/roadway_dept/night_visib/sign_visib/sheetguide/</a></p> <p><b>Corrective Actions:</b> Replace all signs with Type III sheeting or better.</p>

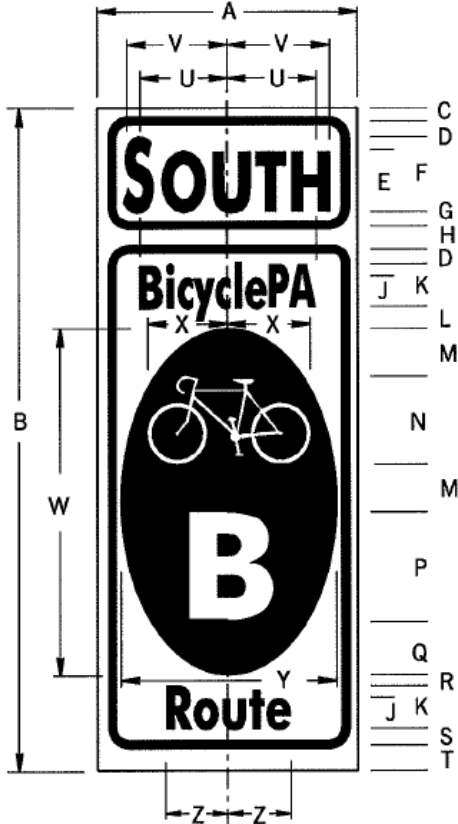
<p><b>Deficiencies:</b> The bicycle route signs on Market Street (eastbound direction) can give confusing information. J Route North continues left on Front Street. J Route left is a sub-route of Bike Route J continuing in the eastern direction.</p> <p><b>Corrective Actions:</b> Replace the bicycle route sign in the bottom left photo with the standard PennDOT M1-8 sign without the direction arrow shown below.</p>

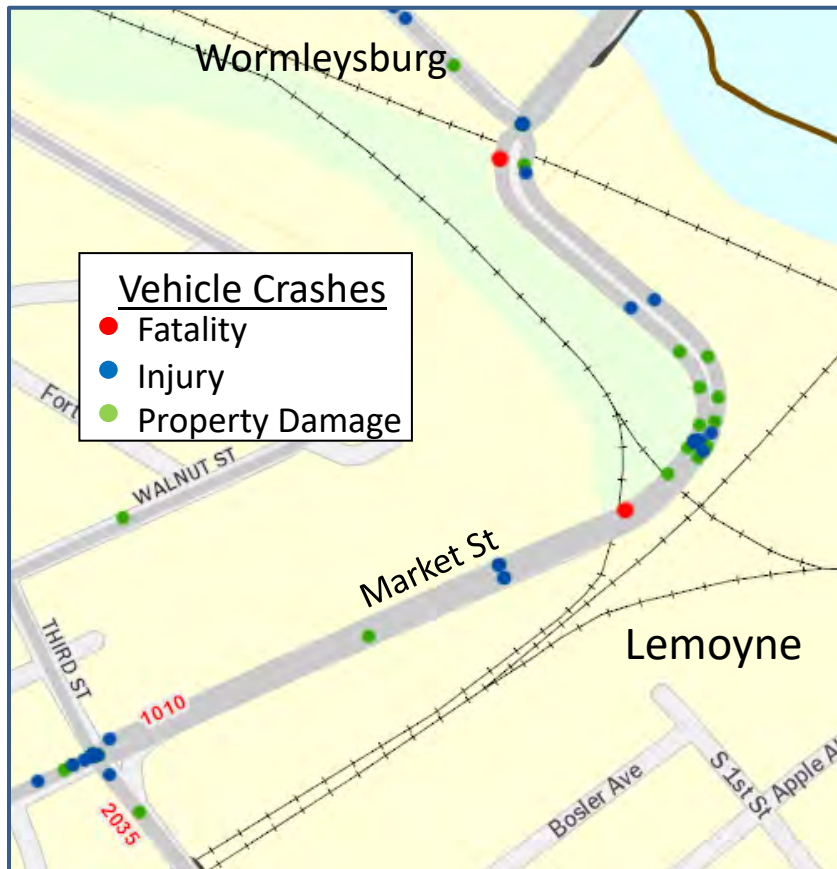
### Exhibit 2.1 Crash Map

Between 2008 and 2017, the most recent year of recorded data, there were no reportable crashes involving bicyclists or pedestrians within the study corridor. However, over the 10-year period, there were approximately 33 reportable crashes along Market Street between the Market Street bridge in Wormleysburg and the intersection with 3<sup>rd</sup> Street in Lemoyne Borough as shown in Exhibit 2.1, including two vehicle crashes involving fatalities. Most of the mapped crashes occurred at the intersection endpoints of the study corridor as well as clustered along the horizontal curve at the midpoint of the roadway segment. Many of the midpoint crashes can be attributed to a combination of inclement weather and the vertical downgrade of Market St. in the eastbound direction.

Although there have been no reported crashes involving bicyclists or pedestrians, the volume of vehicle crashes within the roadway segment remains a significant safety concern for the increasing number of bikers and walkers using this portion of Market Street. As recommended in Chapter 4, installing a bike lane on both sides of the Market Street corridor will provide a safety buffer zone for both bicyclists and pedestrians helping to reduce potential conflicts with vehicles. In order to accommodate the roadway width

required to install these bike lanes, the current 2-lanes of travel in the eastbound direction of Market St. is recommended to be reduced to one travel lane. The resulting reduction in vehicle travel lanes should help to improve the safety of bike and pedestrian travel by reducing vehicle conflict points with the elimination of vehicle passing movements in the eastbound direction and by providing an increase in the distance between the vehicle travel lanes and the bicyclists/pedestrians. In addition, it is anticipated that the lane reduction will “calm” or reduce the speed of traffic in the eastbound direction.
